**Remedial Action Closure Report
Sears Unit 1310
300 Midway Boulevard
Elyria, Ohio
Incident No. 4732300-00
Release No. 47000451-N00001**

**REMEDIAL ACTION CLOSURE REPORT
SEARS UNIT 1310
300 MIDWAY BOULEVARD
ELYRIA, OHIO
INCIDENT NO. 4732300-00
RELEASE NO. 47000451-N00001**

**JUNE 14, 2004
PROJECT NO. 80026.03**

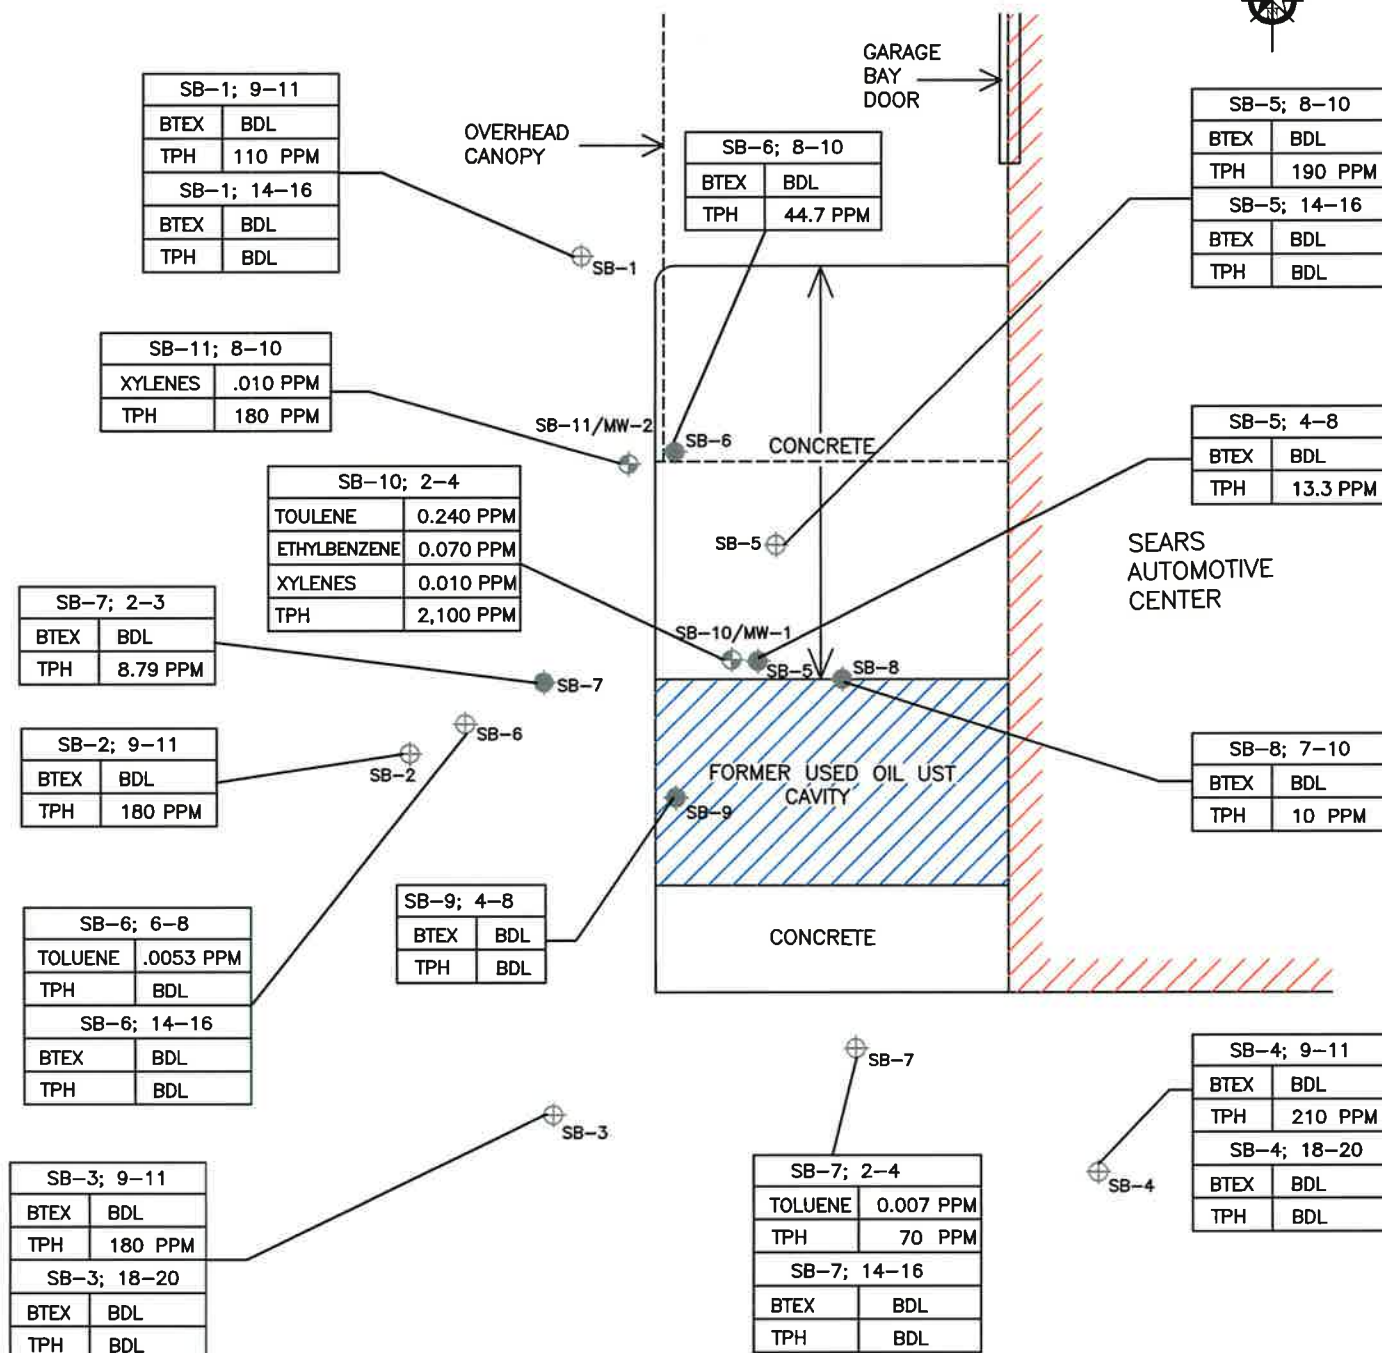
The two soil samples were submitted for laboratory analysis of BTEX using U.S. EPA Method 8260 and for TPH using U.S. EPA Method 418.1. The concentration of TPH detected in the soil sample collected from SB-10 (2' - 4'), located in the vicinity of the previous boring SB-5 and the north wall of the former cavity, exceeded its BUSTR action level. The concentrations of BTEX in SB-10, and

BTEX and TPH in SB-11 did not exceed the BUSTR Category 3 Action Levels. Refer to Table 1.0 and Figure 3.0 for a summary of the soil analytical results.

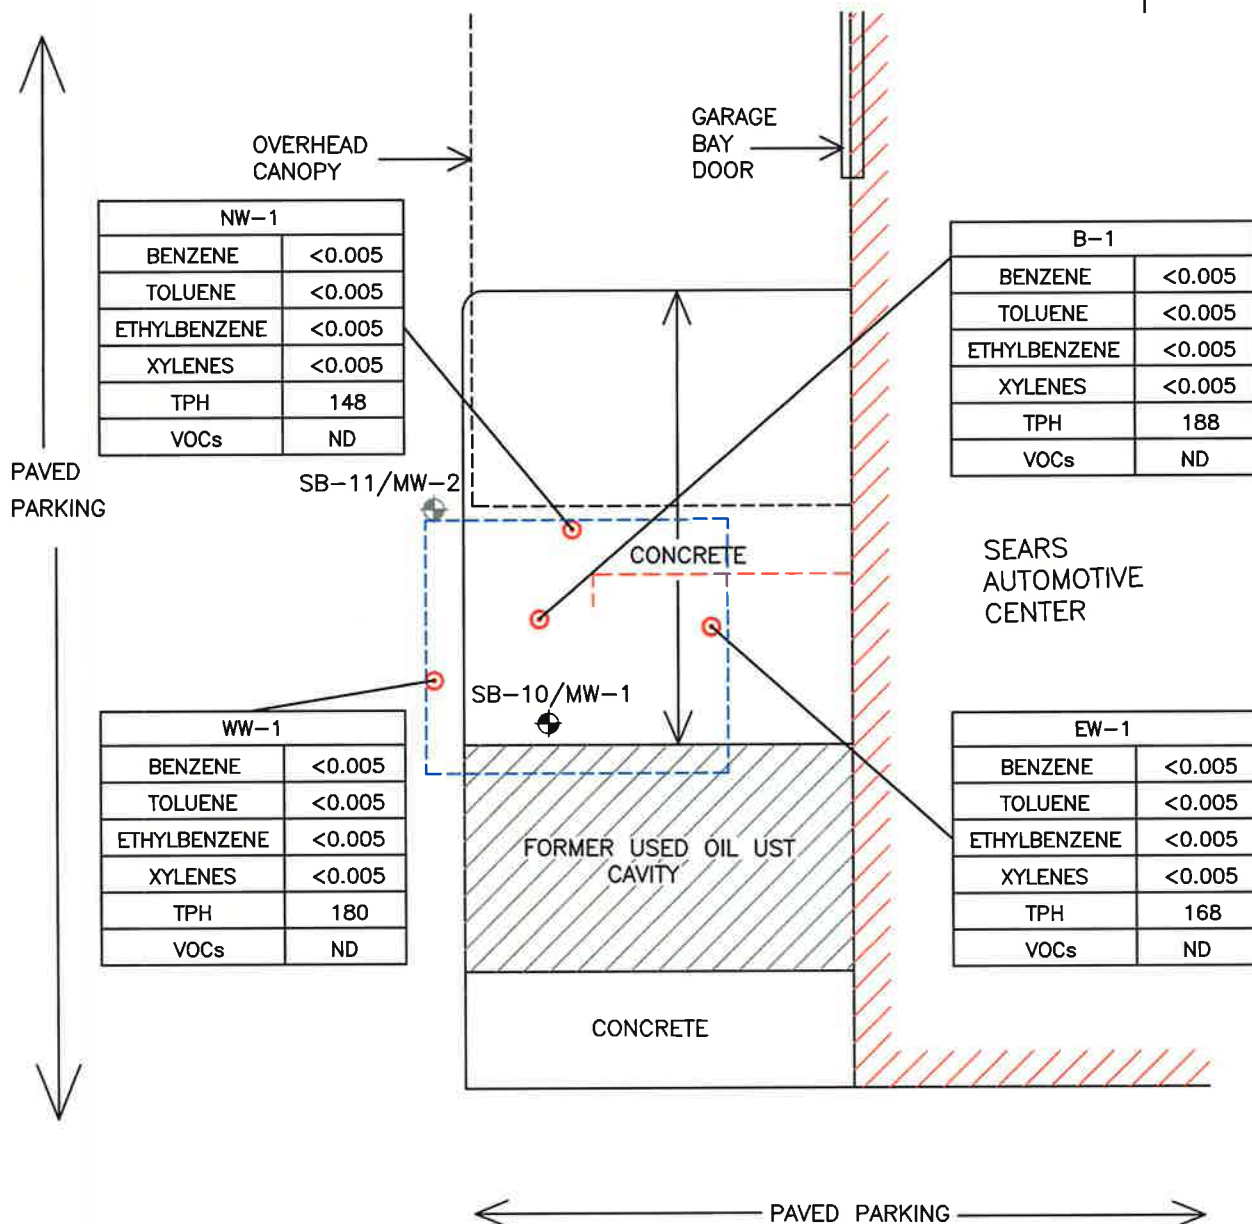
FIGURE 4.0 EXCAVATION SOIL ANALYTICAL SAMPLING RESULTS

The analytical report is included in Appendix C. Concentrations of TPH were measured from 148 ppm to 188 ppm. Sample concentrations measured did not exceed the BUSTR Category 3 Action Level for TPH. Benzene, toluene, ethylbenzene, and xylenes measured below laboratory analytical detection limits for all samples collected. Refer to Table 1.0 and Figure 4.0 for a summary of the analytical results.

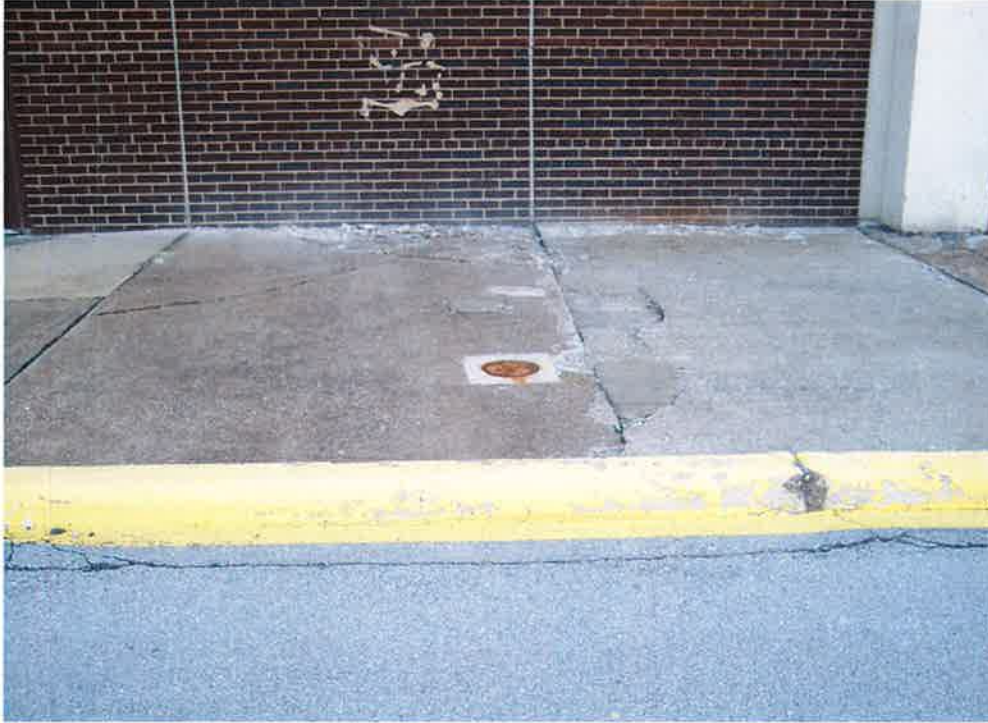
Photo 1: Looking easterly towards the former waste oil UST cavity (to the right) prior to excavation activities. Note monitoring well MW-1 just north of the former UST cavity.

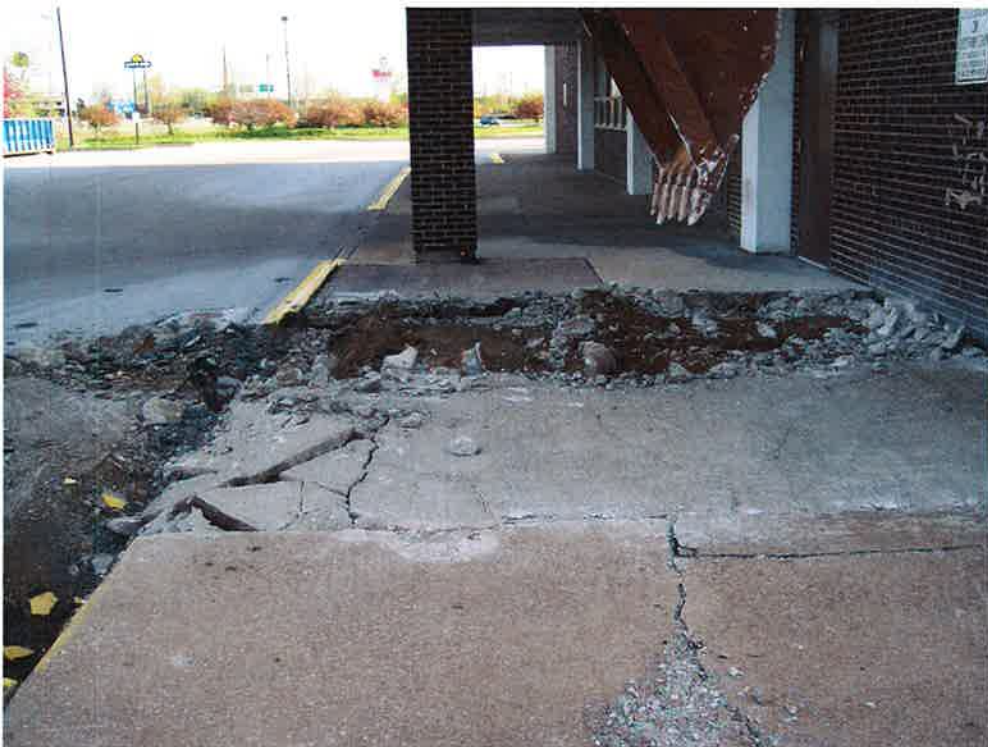
Photo 2: Looking at the northerly at the beginning of excavation activities.

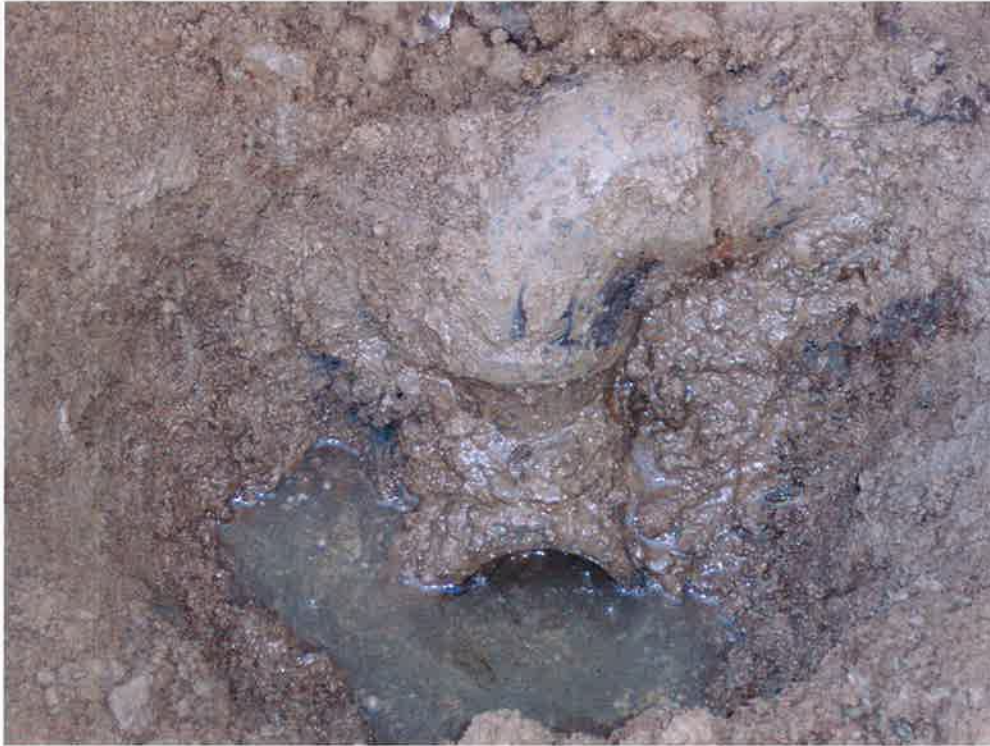
During excavation activities, a piping remnant was encountered of the apparent remote fill line for the former used oil UST. This pipe was encountered in the area of the identified impacts. The pipe remnant was cut off near the building and it was sealed on both the outside and inside of the Sears Auto Center building. Soil was removed in all directions until the visible signs of impact were removed from the area in the vicinity of boring SB-10 (and the former northern wall of the used oil UST cavity). This excavation continued to the south until clean pea gravel was encountered, which indicated the former UST cavity. At this point, no soil was remaining to the southern extent of the cavity and a sample was not taken from the pea gravel. No impacts were noted on the east, north or west walls. Samples EW-1, NW-1, and WW-1 were collected from the east, north, and west walls, respectively, and analyzed by a mobile laboratory. Excavation activities continued until the base depth of 6 feet bgs was achieved throughout the cavity. No impacts or petroleum odors were noted. The excavation base was then sampled, B-1, at approximately 6 feet bgs.

Photo 3: View of the abandoned pipe from the former used oil UST. This pipe was removed prior to backfilling the excavation.

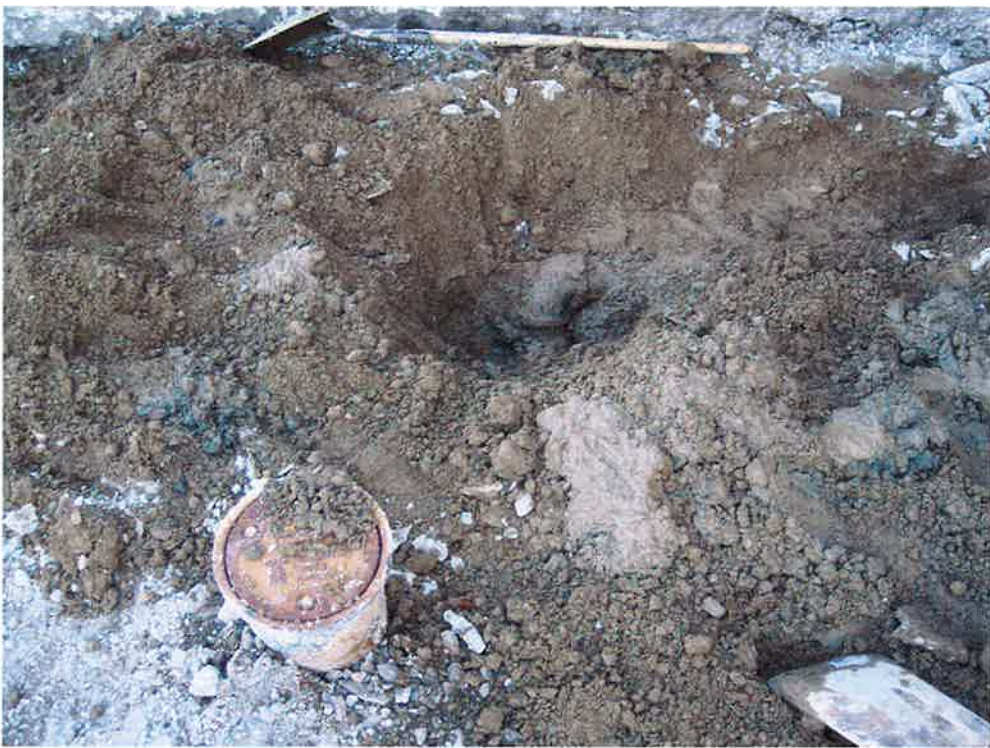
Figure 4: View of the monitoring well MW-1 and the abandoned pipe.

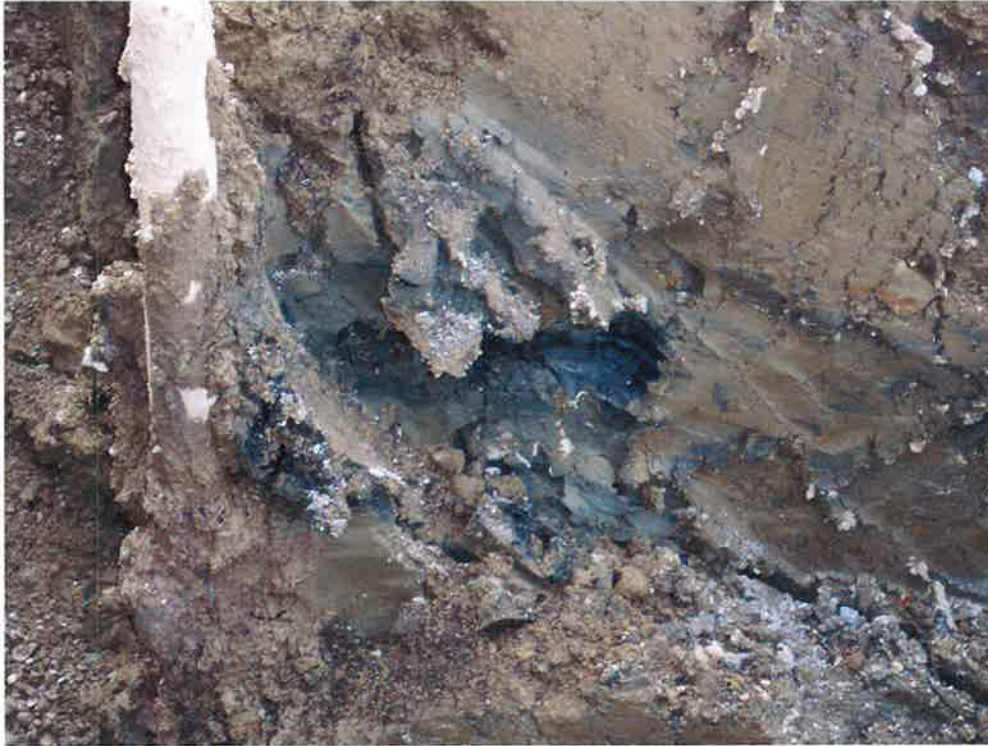
Staining and petroleum odor was noted during the soil screening process at a depth of approximately 2 to 4 feet bgs along the southern wall. This impacted material was excavated and stockpiled for off-site disposal. No impacts were noted along the northern, eastern, or western walls. Based on the RAP, site observations, professional judgment, and the nature of the release at the site, soil samples from each wall (except the south wall as noted above), a base sample, and one sample from the stockpile were submitted for laboratory analysis.

Photo 5: Southerly view of the impacted soil seam along the south wall of the excavation prior to its removal.

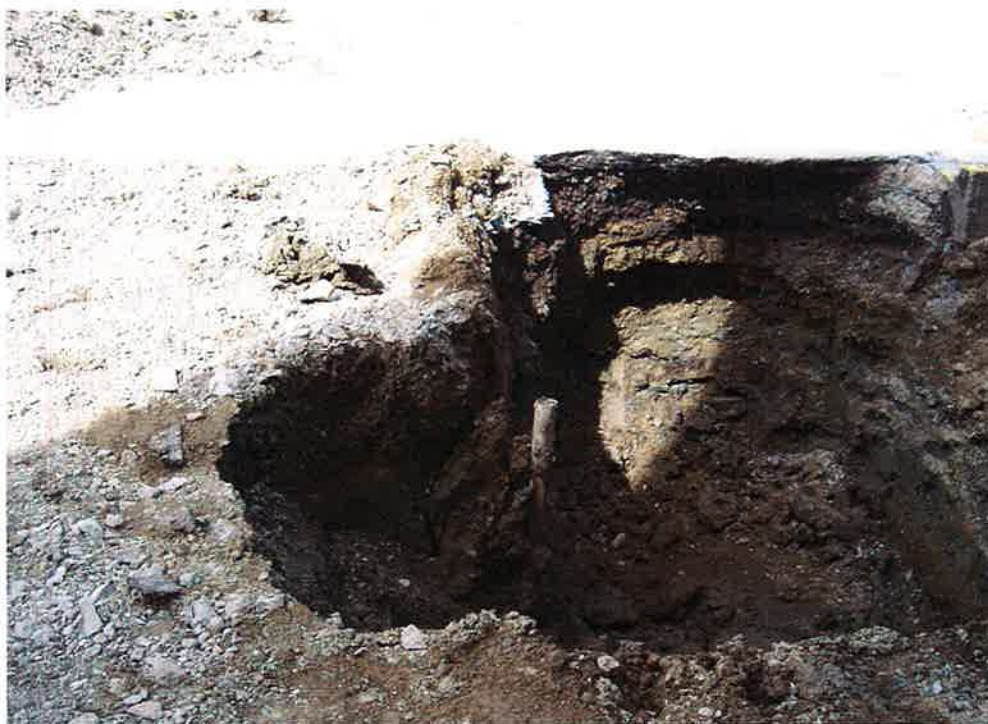
Photo 6: Westerly view of the excavation. Note the pea gravel cave-in (bottom left) from the former UST cavity.

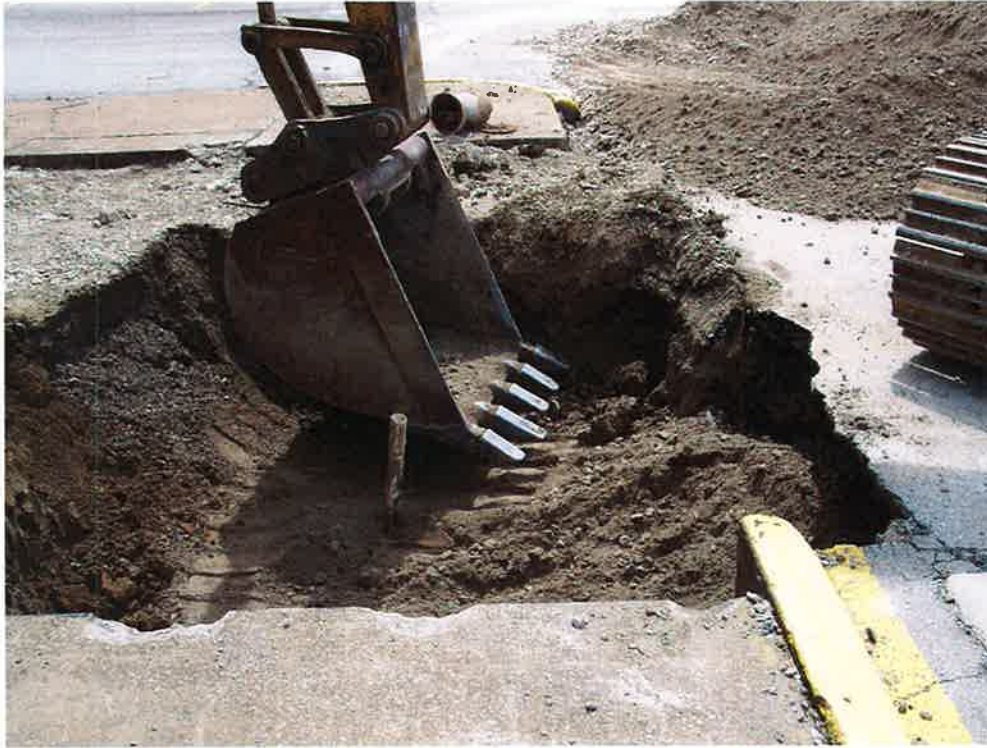
Photo 7: View of the excavation during backfilling activities. MW-1 and MW-2 (bottom right of photograph) were cut three feet below grade and sealed.

Groundwater was not encountered during the excavation activities. In accordance with the RAP, monitoring wells MW-1 and MW-2 were decommissioned. Both monitoring wells were cut approximately 3 feet bgs and filled with bentonite to seal the wells. This procedure followed Ohio Department of Natural Resources procedures for well abandonment. Refer to Appendix D for a copy of the Water Well Sealing Report for these monitoring wells.

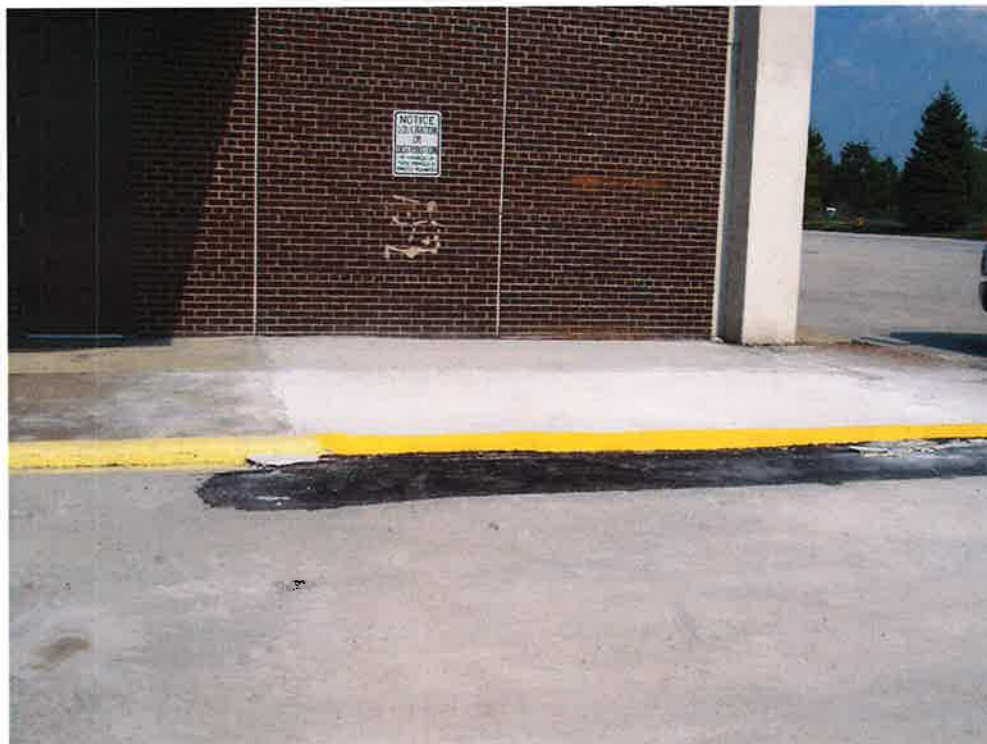
Photo 8: Looking easterly at the completed excavation and restored concrete and asphalt.

All excavation materials were stockpiled and then placed into a roll-off box for disposal. The impacted soil was transported to American Landfill in Waynesburg, Ohio for disposal (refer to Appendix B). The remainder of the excavation area was backfilled with self-compacting gravel and marked with caution tape until the concrete sidewalk was replaced and the surrounding area was re-paved.
