# LORAIN COUNTY ENGINEER

Re: Preliminary Report of **Roth Main Ditch & Lateral #1 Restoration**, Columbia Twp.

### Project Description

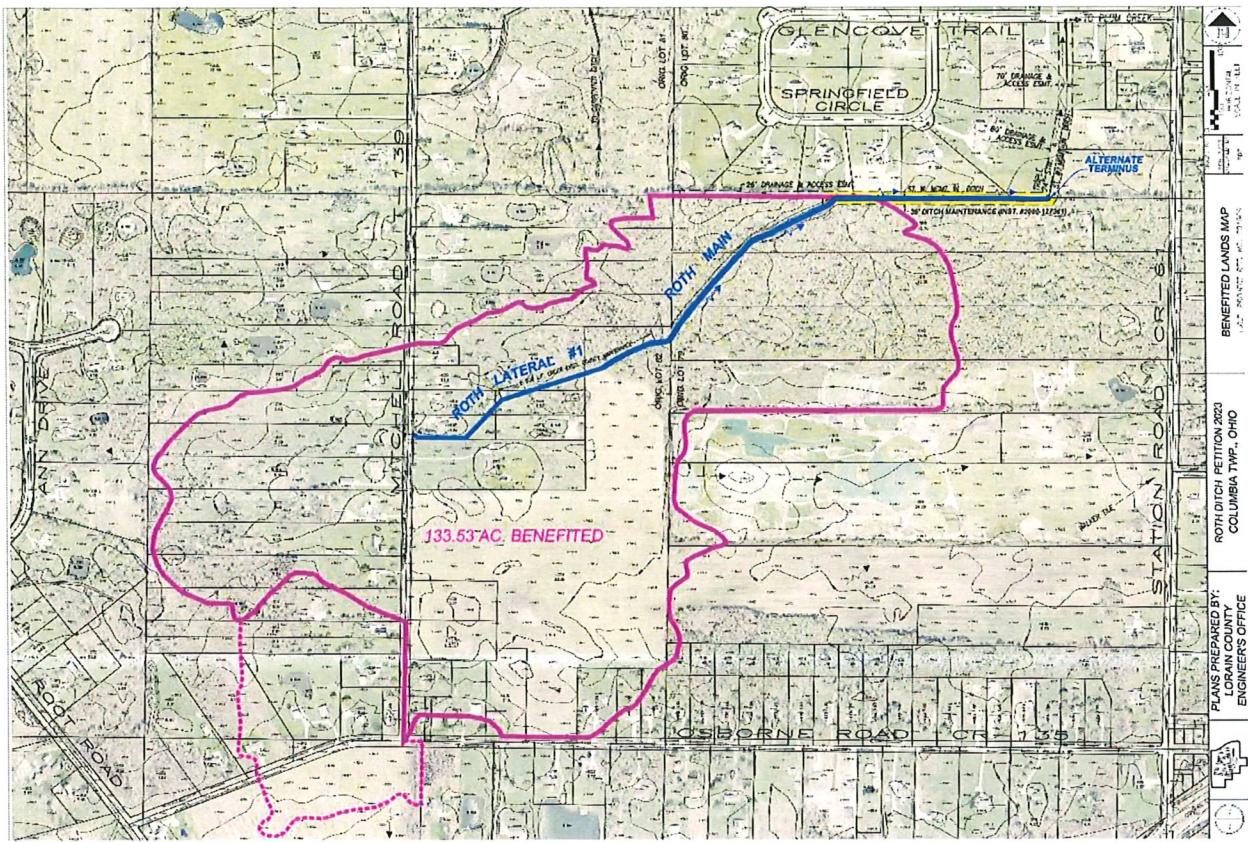
Figure 1. Map showing the lands to be benefitted by the Roth Main Ditch & Lateral #1 Restoration improvement, with the Engineer's recommended alternate terminus in yellow highlight at the upper right.

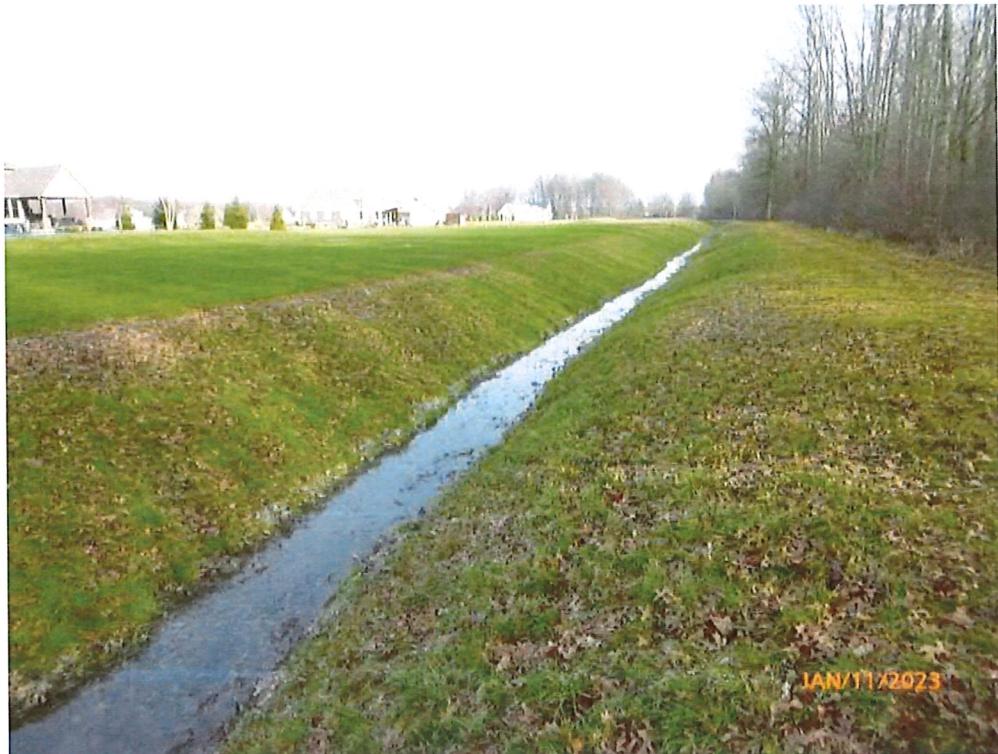
↑ Existing ditch route along the south line of Stone Ridge Estates Subdivision

9. Preliminary engineering analysis indicates the need to deepen the pictured portion of the ditch as part of this improvement, however. In fact, the recommended deepening will restore the flow line to match the original depth of the Roth Tile that was installed there in 1917. This will provide for an improved hydraulic gradient upstream all the way to Mitchell Road. The amount of deepening will be determined by final engineering, and will be based upon completed topographic surveying. The County Engineer proposes this “alternate” to the original petition in order to provide an adequate drainage outlet. The recommended route is visible in the above photograph, with the alternate terminus in the distance (see also Page 16 for a close-up photo at the location of the terminus).

Deepening this ditch will not adversely impact the drainage of the subdivision. It will increase the capacity of the subdivision’s existing storm water management facility, and will thereby afford further flood protection to the adjacent properties. Therefore, the effect on adjacent lands and lands below the terminus is expected to be positive.

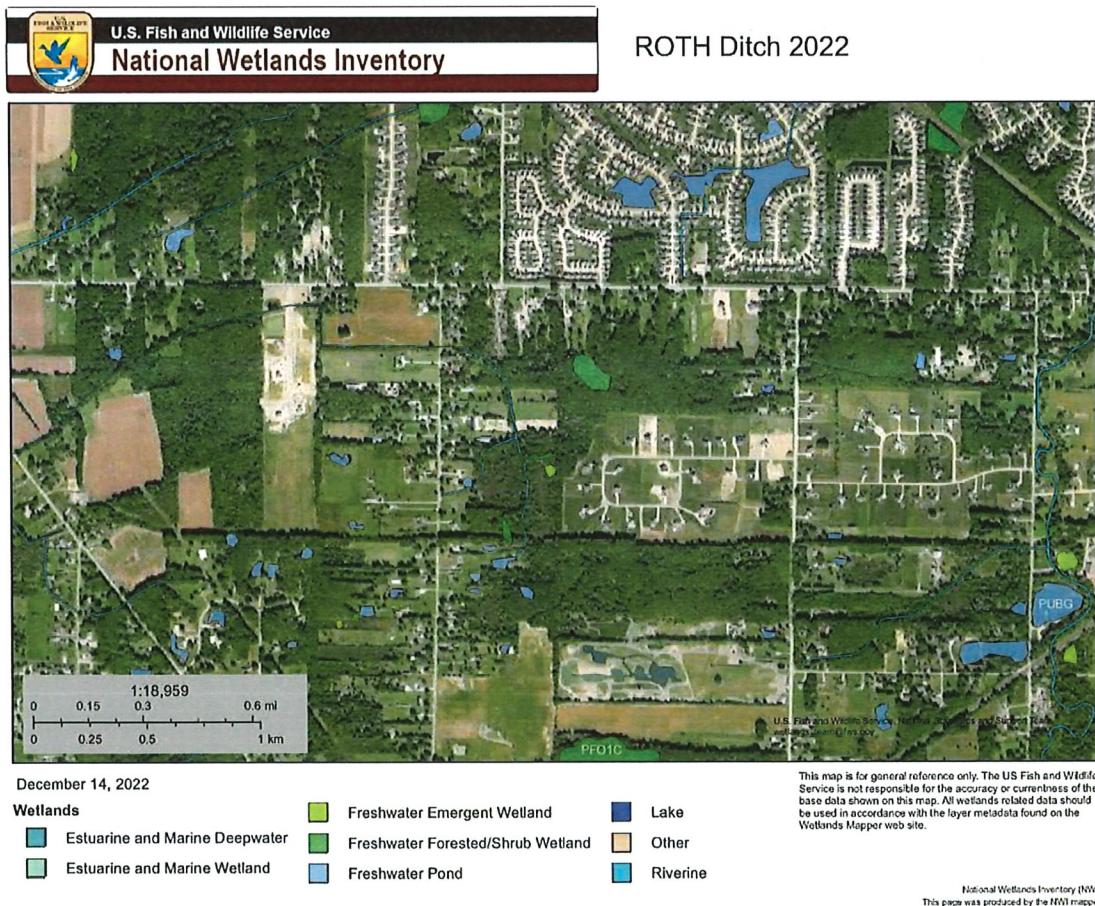
17. Further analysis of wetlands and environmental constraints may substantially impact the costs estimated in this report. Although the National Wetlands Inventory Map (see map below) does not indicate significant conflicts, further environmental investigation will be necessary. Additional costs may include the need for consultants, US Army Corps of Engineers or Ohio EPA permits, costs associated with additional construction requirements, mitigation costs, etc.

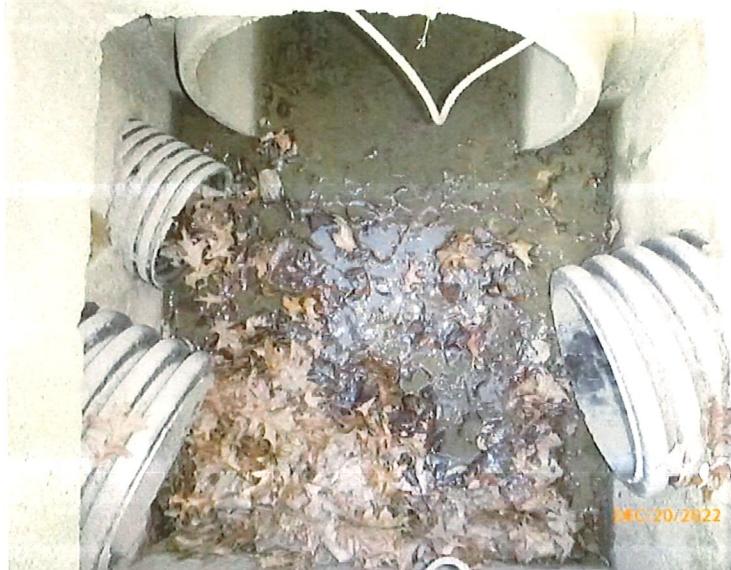
A. The first leg of the 12-inch "tile" runs 0.1 mile eastward from Mitchell Road (a township road), where it is fed by several other storm sewers that drain the roadside plus land west of Mitchell Road. The several storm drain pipes and the 24" roadway culvert are pictured converging inside the catch basin at #10955 Mitchell Rd:

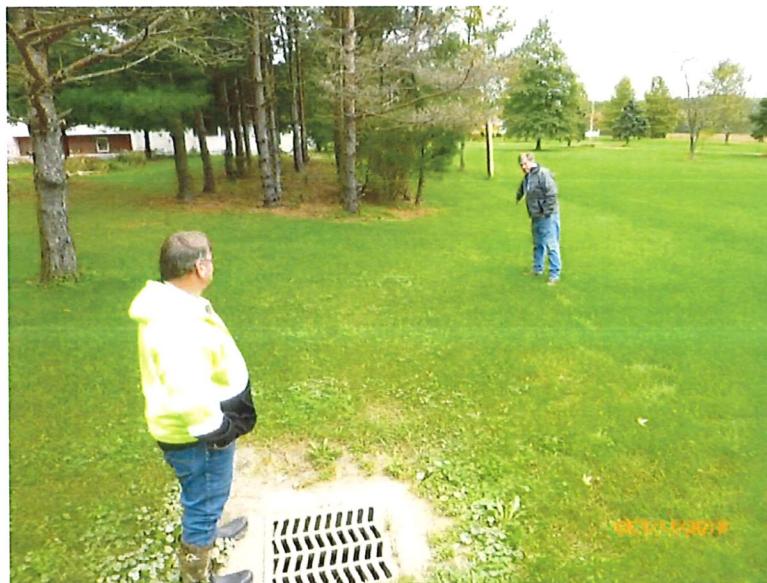
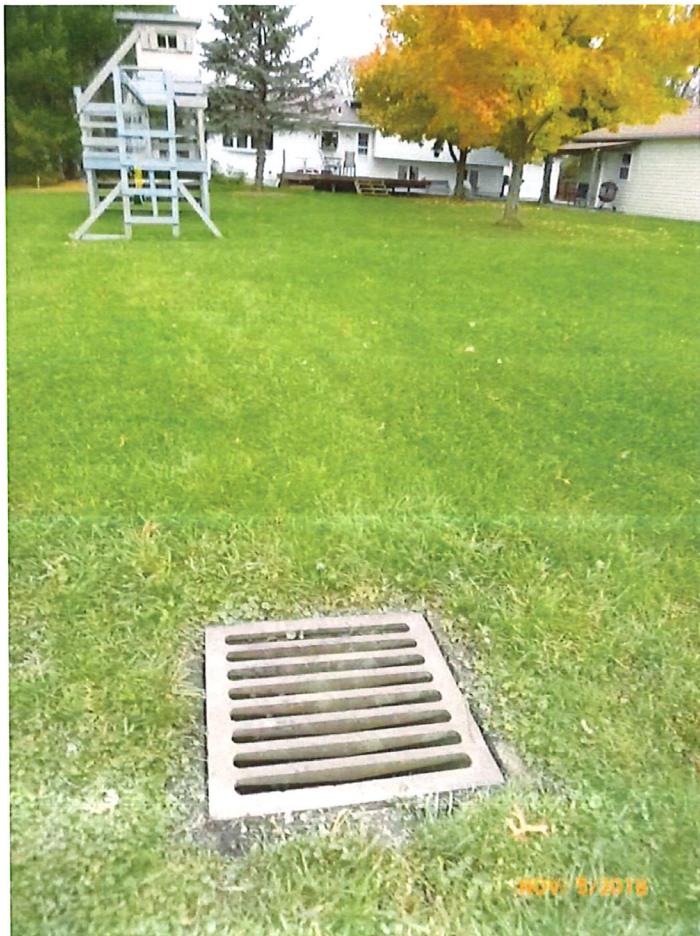
This first leg is privately owned--it is not under County maintenance, and it lies mostly under the Smith property at 10955 Mitchell Rd (photos show Smith's front & backyard):

↑ This run of (underground) pipe reportedly is composed of single-wall corrugated HDPE material, which is considered to be substandard pipe material for this application. It is also prone to maintenance problems, especially from intrusion by tree roots, or from poor alignment. The County Engineer successfully sewer-jetted a blockage in 2018, but could not succeed in removing a subsequent blockage in 2020. Smith, the homeowner, reportedly repaired at least one collapsed pipe section in 2022, and more recently he observed another sinkhole develop over the pipe.

Smith and others have reported significant basement flood damage (including structural damage) at #10955 and #10934 Mitchell Road.

6. Inadequate drain pipes now run through portions of the drainage system, and should be reconstructed and upgraded to adequate sizes and slopes. The County Engineer recommends to remove and replace the existing drains because they are substandard or otherwise inadequate.

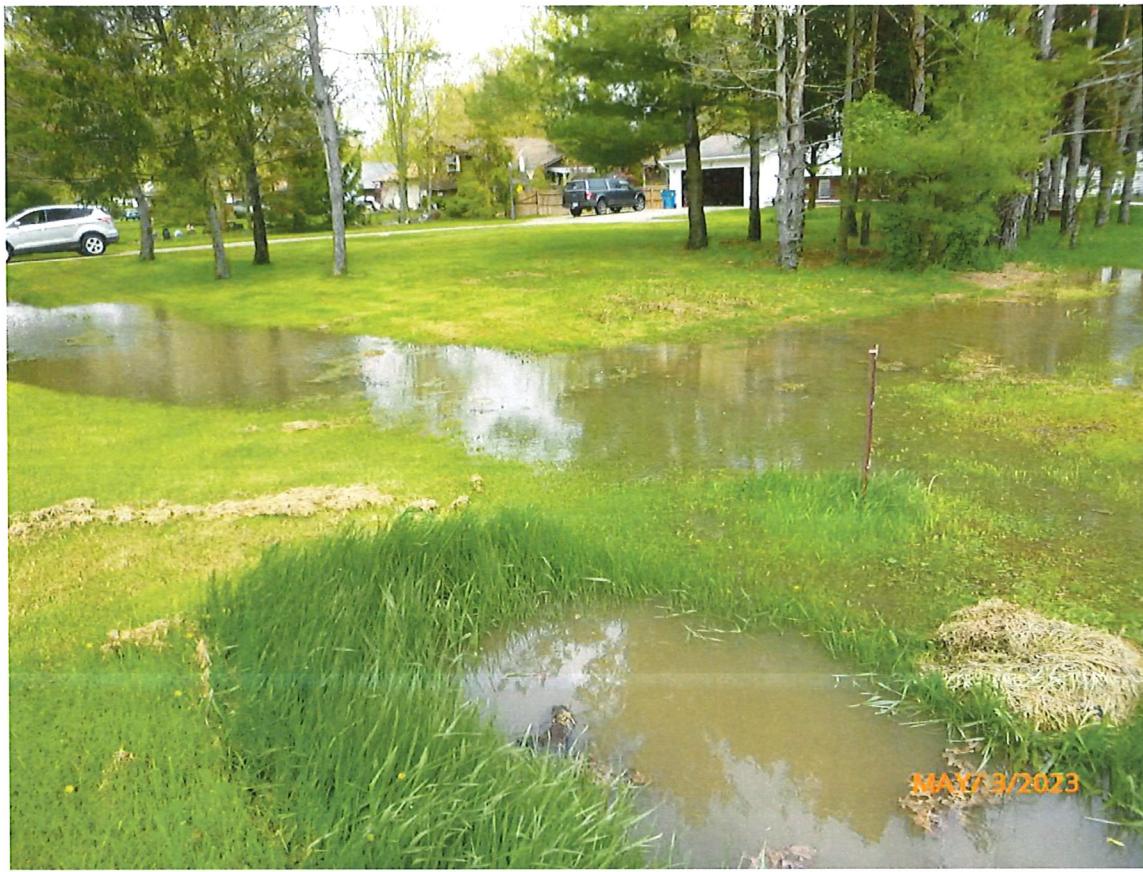
This run of pipe appears to drain very slowly, and adjacent yards often exhibit standing water for several days after heavy rains, as visible in the following photographs:

Standing water in the front yards and roadside of #10955 ↑, and #10969 ↓ Mitchell Rd.

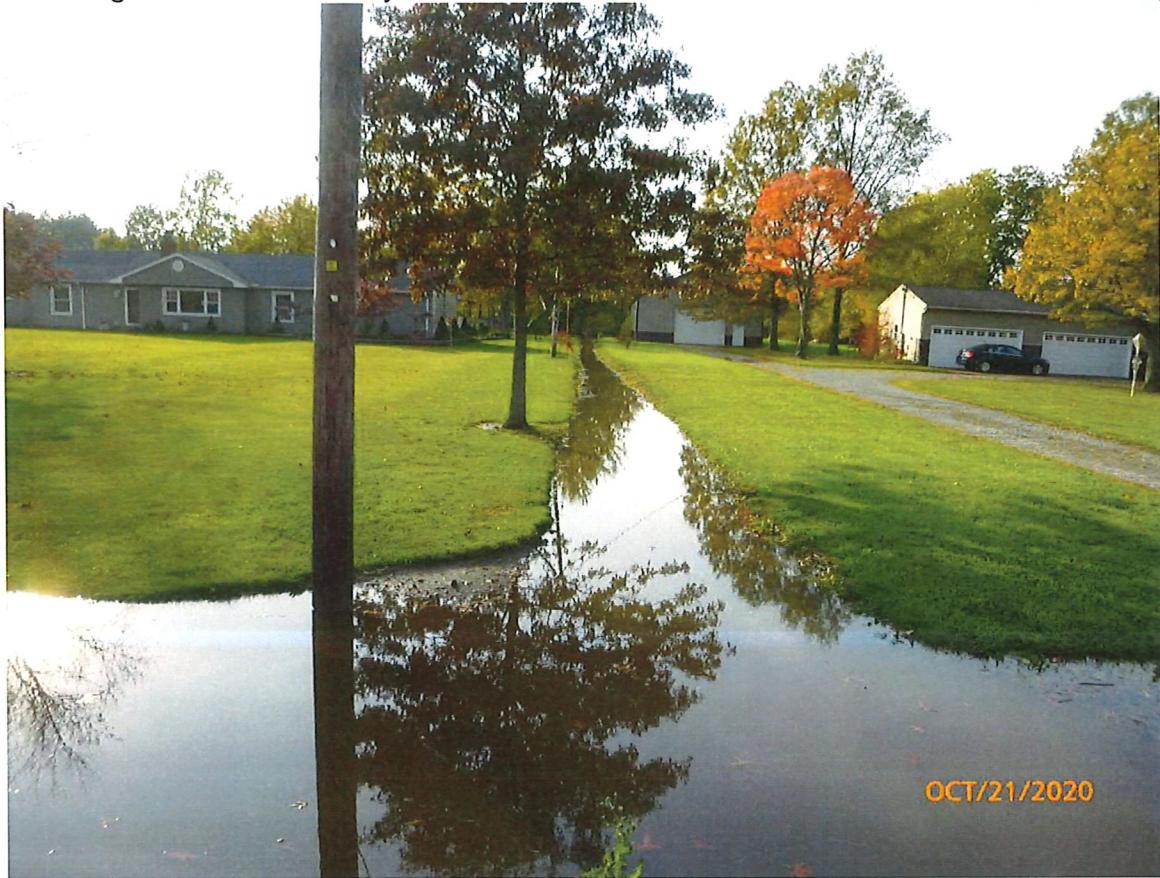
Standing water in the front yards and roadside ditch at #10934-10890 Mitchell Rd.↓

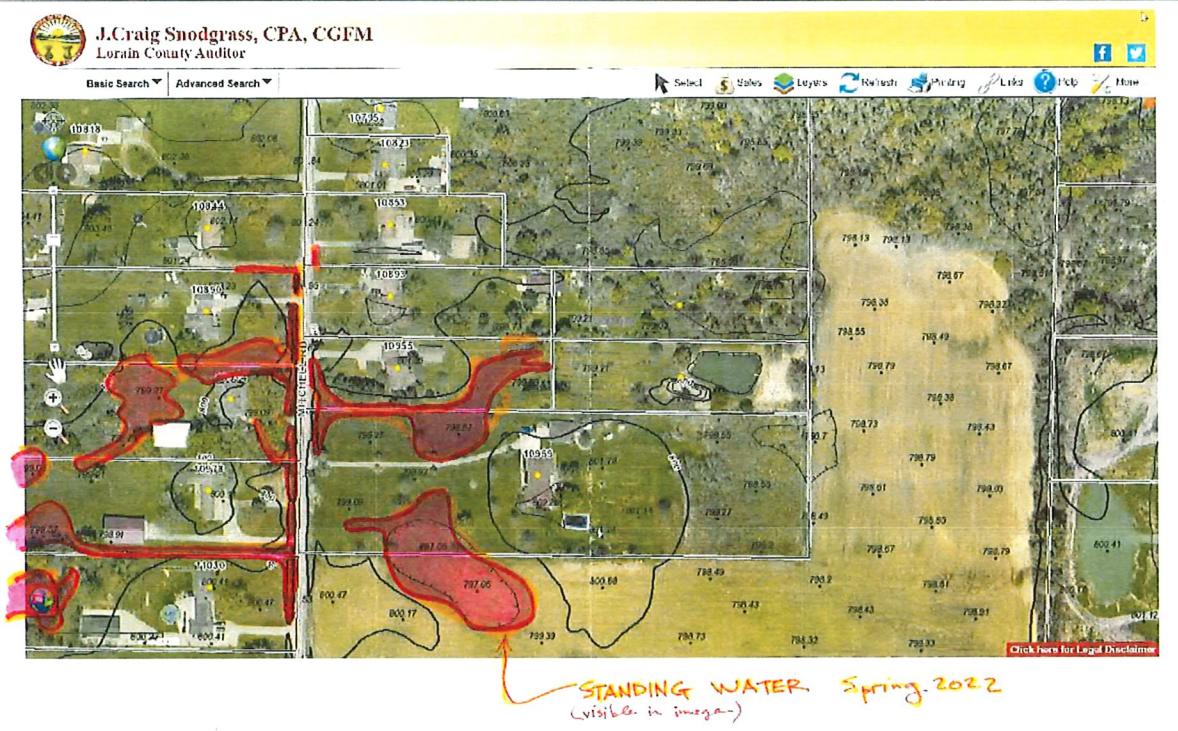
Areas of standing water on flooded farm and yards in Spring 2022 are visible in the aerial image of the neighborhood, and are highlighted in red below ↓

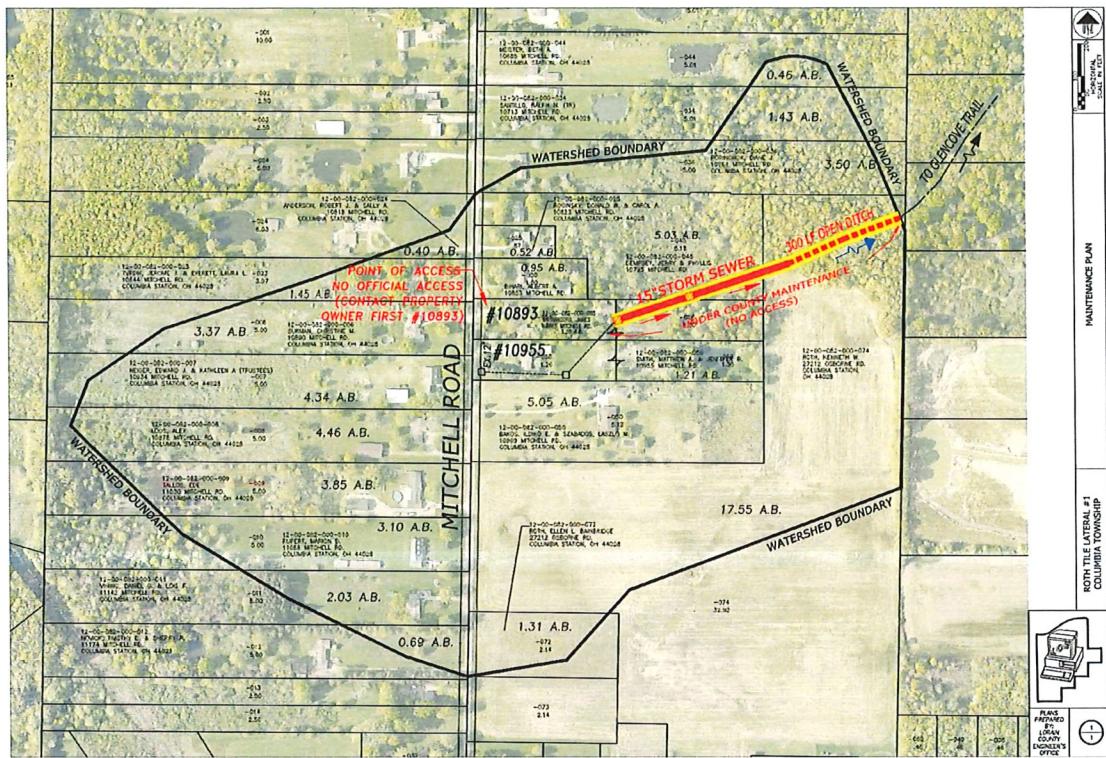
B. The County is currently charged with the maintenance of the next 0.15 mile of the "Roth Tile Lateral Improvement" downstream as shown here in yellow and red colors:

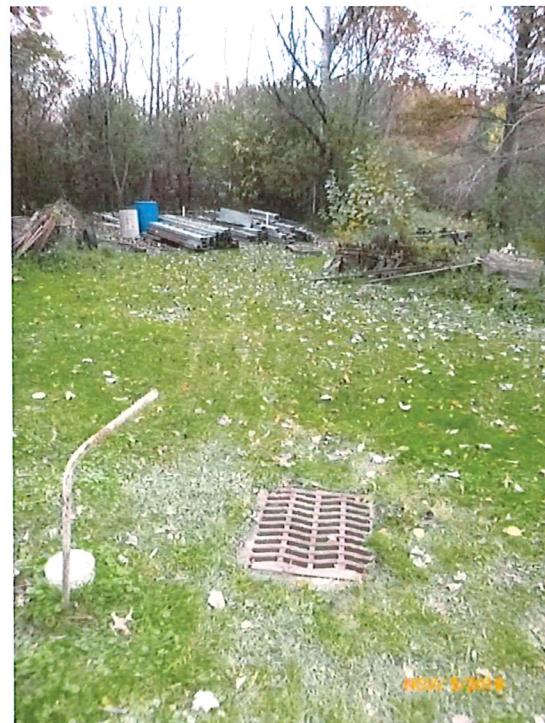
The County's maintenance consists of the 15" diameter double-wall storm drain pipe. The catch basins in the rear of #10893 Mitchell Road is pictured below. The 15" pipe extends underground through the brush at the upper right of this photograph ↓

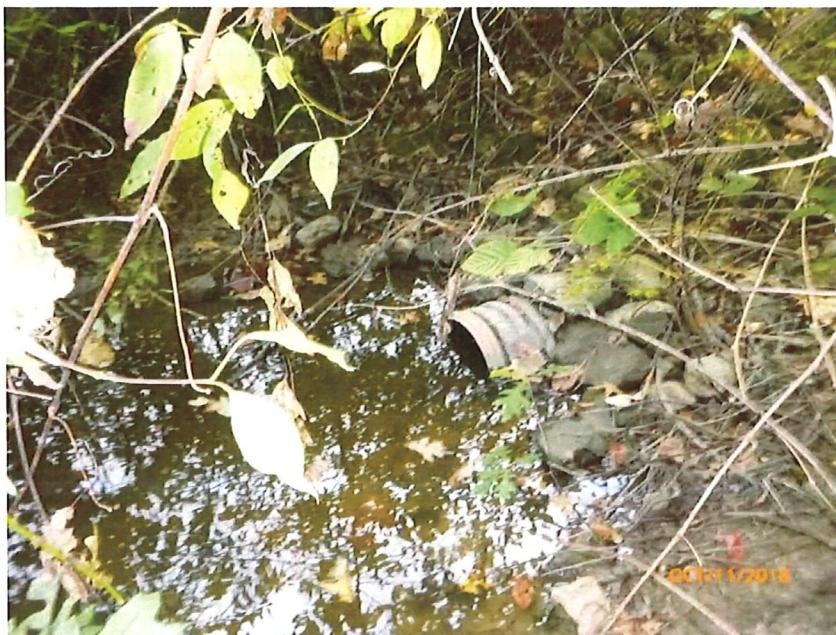
However, this run of pipe suffers from poor access, and may also suffer from inadequate size, depth and flat gradient. Its poor outfall into the shallow standing water of the open ditch is pictured next. This run of pipe, installed in 2009, otherwise remains in good structural condition ↓

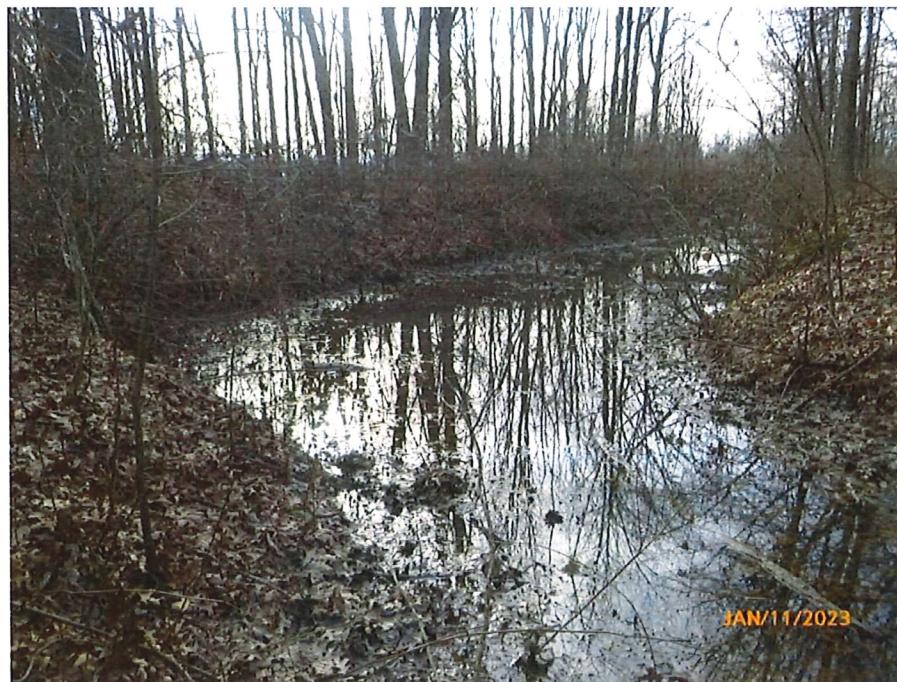
Significantly, this short County-maintained ditch reach suffers from no access at all—it is landlocked. This recent improvement (also part of the 2009 installation) established no formal access route—which greatly inhibits current maintenance efforts. The following photo looking toward the open ditch on the Roth farm property depicts part of this landlocked ditch area↓

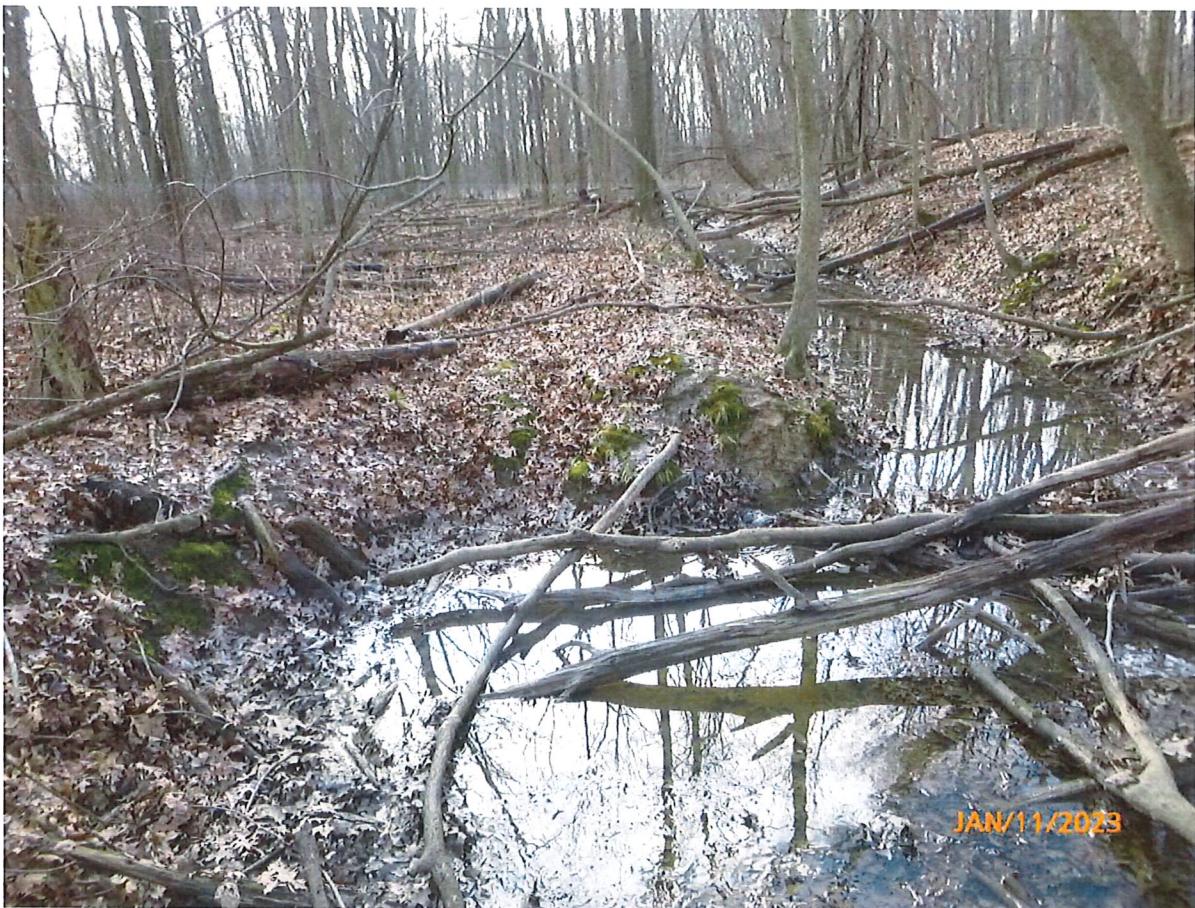
C. The next downstream reach consists of the open ditch that flows through several wooded parcels of land for about 0.25 mile. This wide ditch appears to have been constructed or widened or cleaned in modern times (perhaps about 25 years ago), by unknown parties. Evidently, no one currently maintains this reach, however. Large woody debris in the channel partially obstruct the flow, and contribute to about one foot of standing water in the ditch. An undetermined amount of sediment is visible in the bottom of the channel. Trees have grown up along both sides of the ditch, including growing on top of the spoil piles that were cast along its northwest side ↓.

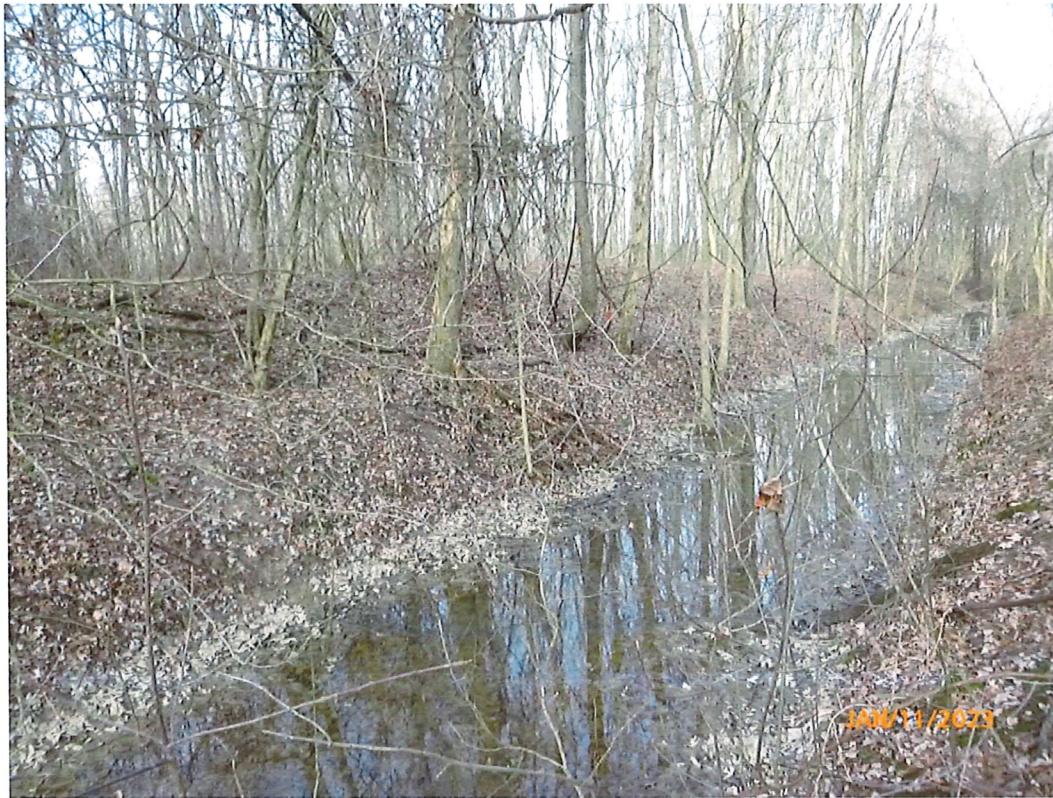
Hydraulically, the flow line gradient in this reach of the ditch is very flat (the topography of the entire watershed is very flat). All these factors contribute to the ditch's very sluggish flow regime. On the following page, see more photos of this reach of the ditch:

↑The existing ditch is wide, but has little fall (or gradient), and has plenty of standing water.

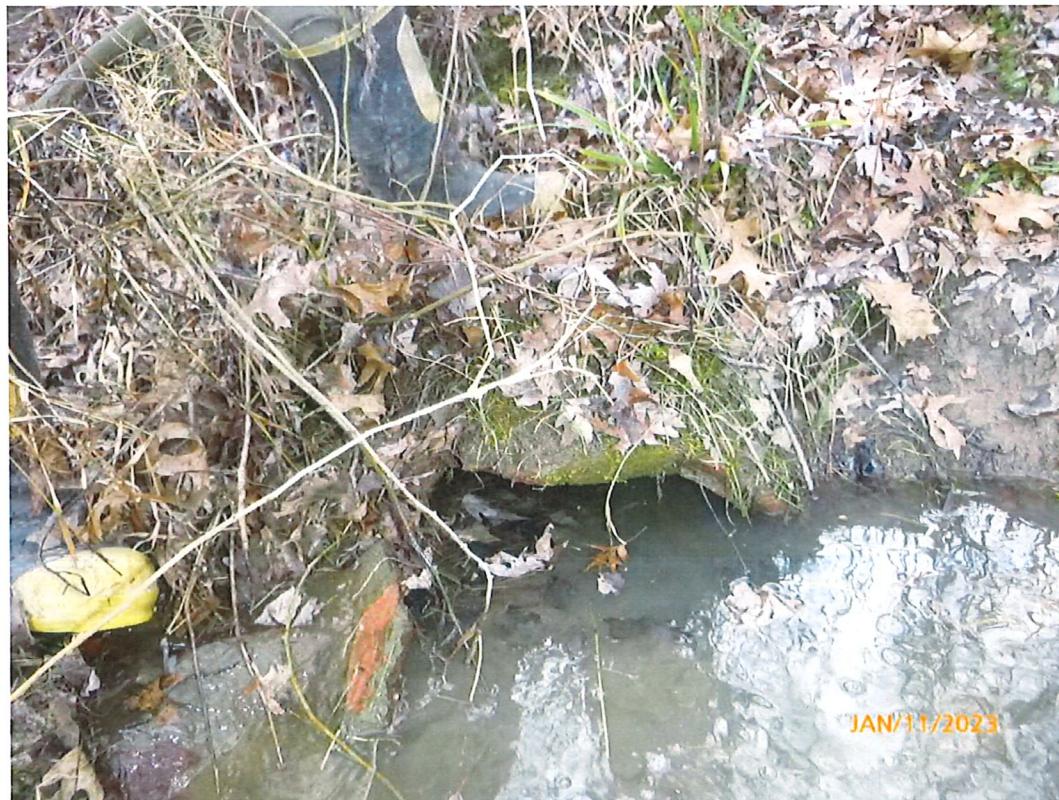
Sinkholes and remnants of the old 22" clay (Roth) tile are sometimes visible alongside the ditch ↓ This condition illustrates the need for deepening the next run of the ditch:

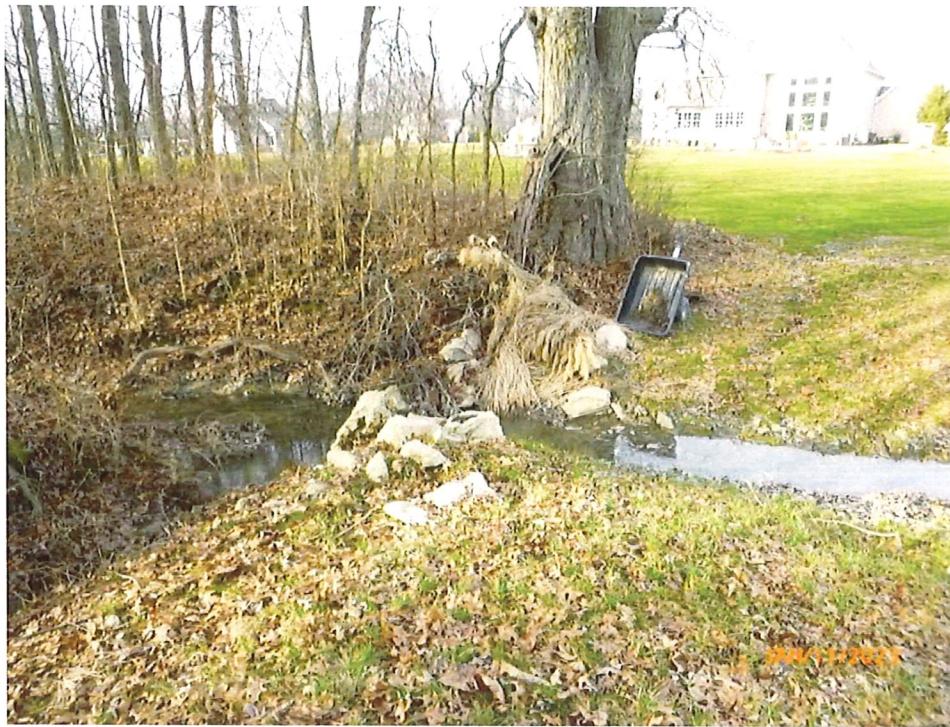
↑ The existing ditch turns east at the south line of Stone Ridge Estates Subdivision

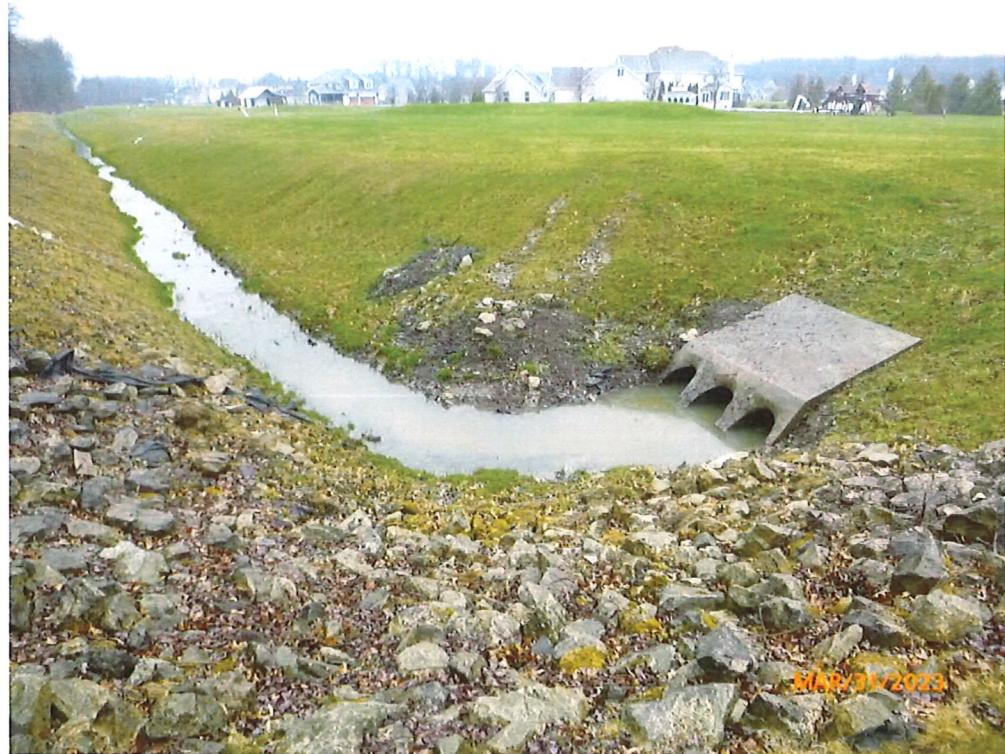
D. The final reach consists of the ditch as it continues to run along the south line of Stone Ridge Estates Subdivision, to its terminus pictured below where the ditch turns north and enters these triple 24" culverts:

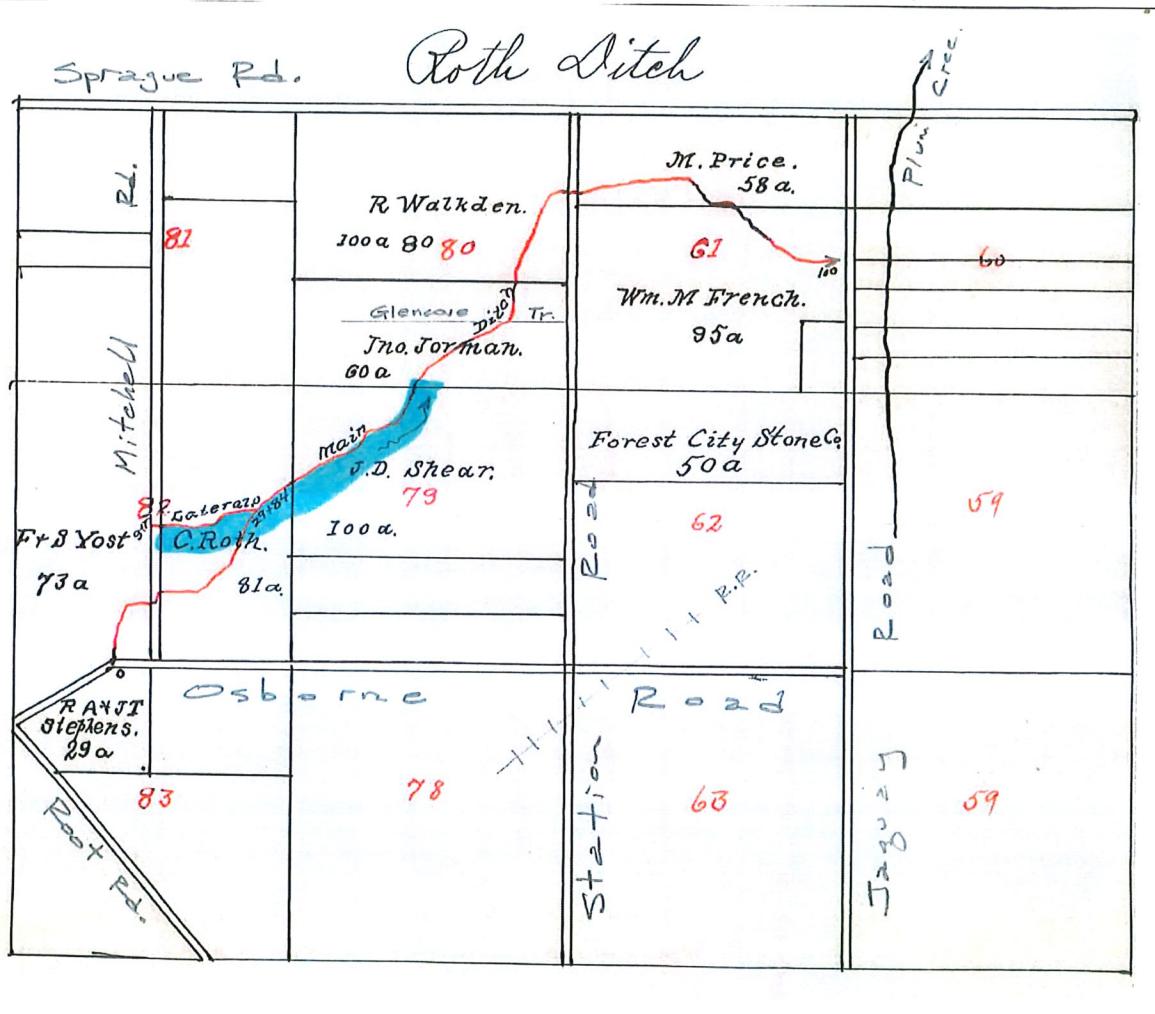
In 1898 and 1904, the County was petitioned and did establish "Roth Ditch." The old map below indicates both the "Main" ditch and its "Lateral." Later in 1917, the County constructed more petitioned improvements that consisted of "tiling" those ditches. No ongoing maintenance by the County was provided for at any of those times, however.

The current petition scope is superimposed in blue color on the old map for reference:
