Phase I Environmental Site Assessment

Sears Department Store, Sears Auto Center, and Red Lobster
Restaurant
4900, 4950, and 6935 Midway Mall
Elyria, Ohio 44035

August 22, 2018

PSI Work Order: 01372333

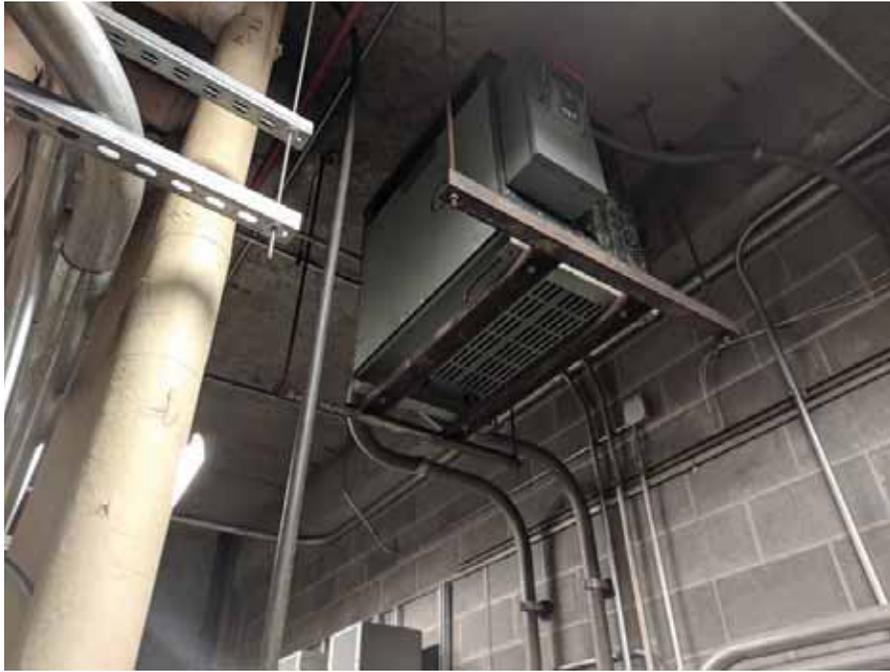
Photo 11: View of a dry-type transformer located in mechanical room on the roof of the Sears store.

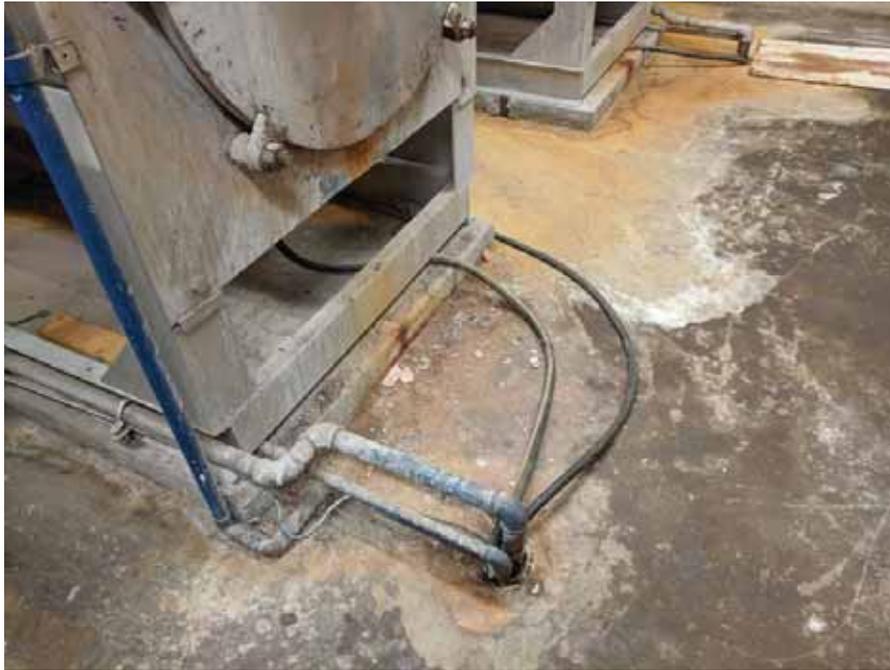
Photo 15: View of a drain located in the mechanical room on the second floor of the Sears store.

PSI observed floor drains in boiler room, restrooms and janitor's closet of the Sears department store. In general, the identified drains appeared in good condition with no odors or signs of misuse or evidence of improper disposal noted. PSI believes the drains ultimately flow into the municipal sanitary sewer system. Based on this information, the presence of the drains is not considered to represent evidence of a REC in connection with the subject property.

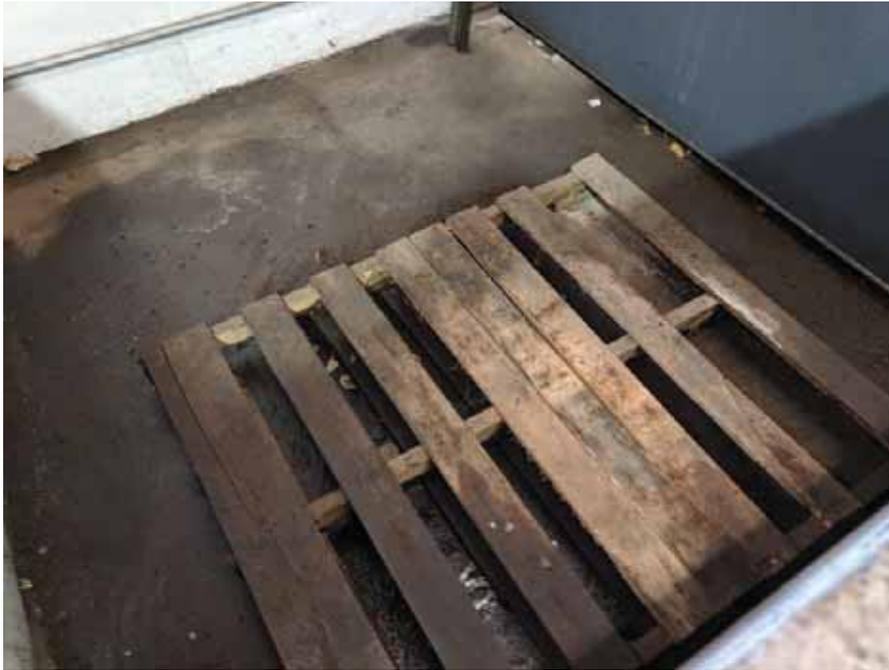
Photo 53: View of oil staining located on the concrete containment area beneath the ASTs.

Three ASTs, including two new oil and one used oil, wer observed within the Sears Auto Center. According to Mr. McMillon, these ASTs were currently empty. The ASTs were located within a concrete secondary containment area. Some staining was observed on the concrete floor of the secondary containment. Based on the secondary containment and indication the ASTs are currently empty, they are not considered to be evidence of a REC in connection with the subject property.

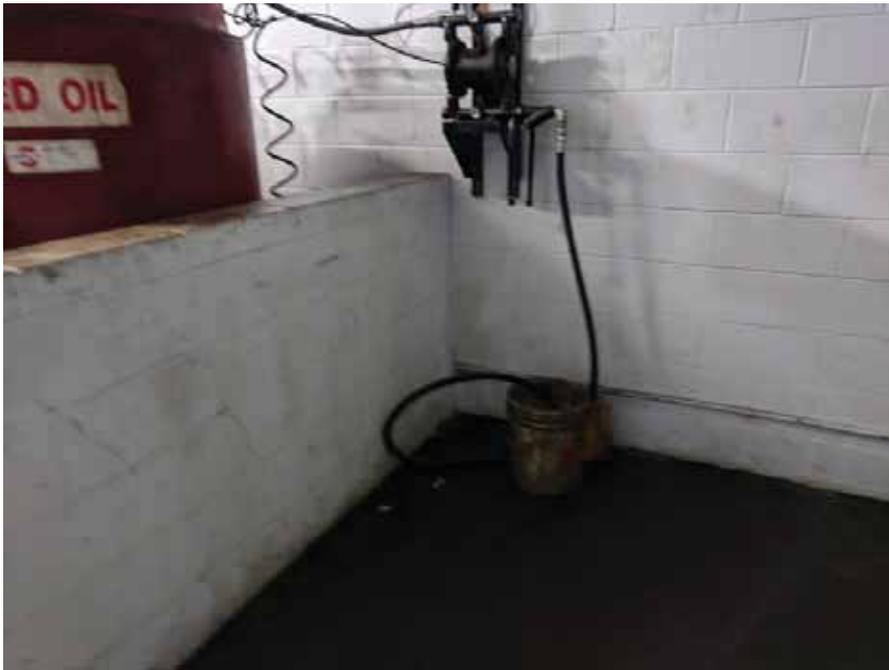
Photo 54: View of oil staining on the concrete outside of the AST containment area.

The remaining minor staining within the auto center appeared to be the result of leakage of automobile fluids and not the result of a large scale spill. PSI considers the presence of the staining a *de minimis* condition and, by definition, not a REC in connection with the subject property.

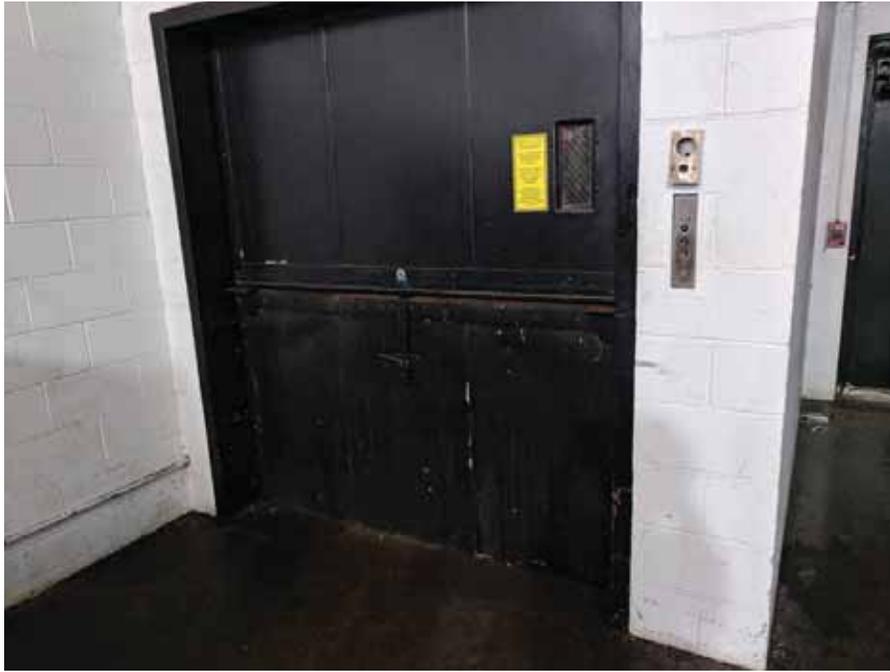
Photo 55: View of the freight elevator located within the Sears Auto Center.

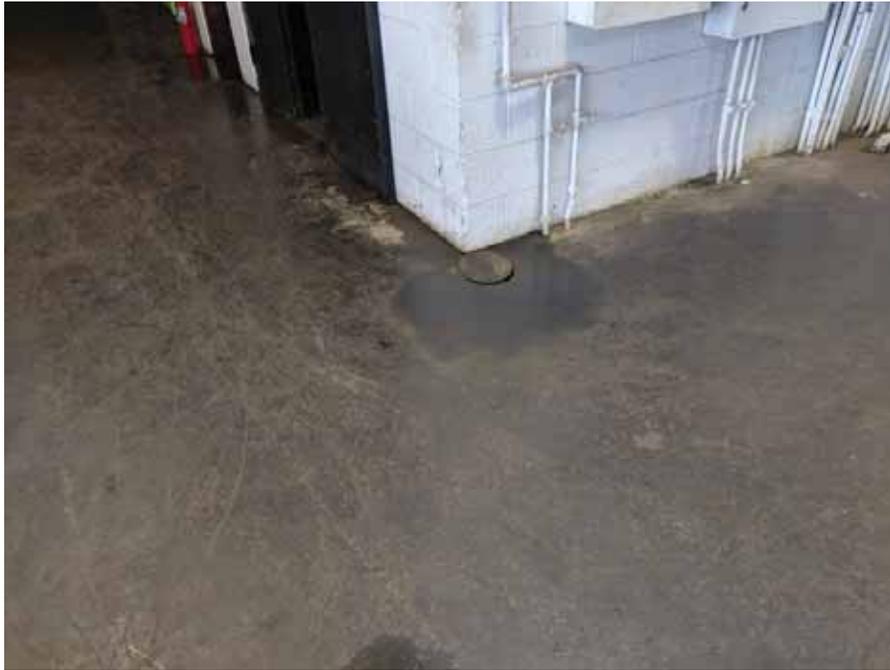
Photo 59: View of a drain that has oil staining around it located within the Sears Auto Center.

PSI observed a former trench drain (now mostly filled with concreted with 5 small drains), drains associated with two wash stations and in the boiler room of the Sears Auto Station. These floor drains are believed to be connected to an oil/water separator located within the building. Based on the fact the drains are connected to the OWS, they are not considered a REC with respect to the subject property; however, due to the age of the OWS and no indication concerning the maintenance of the OWS, it is considered a REC with respect to the subject property.

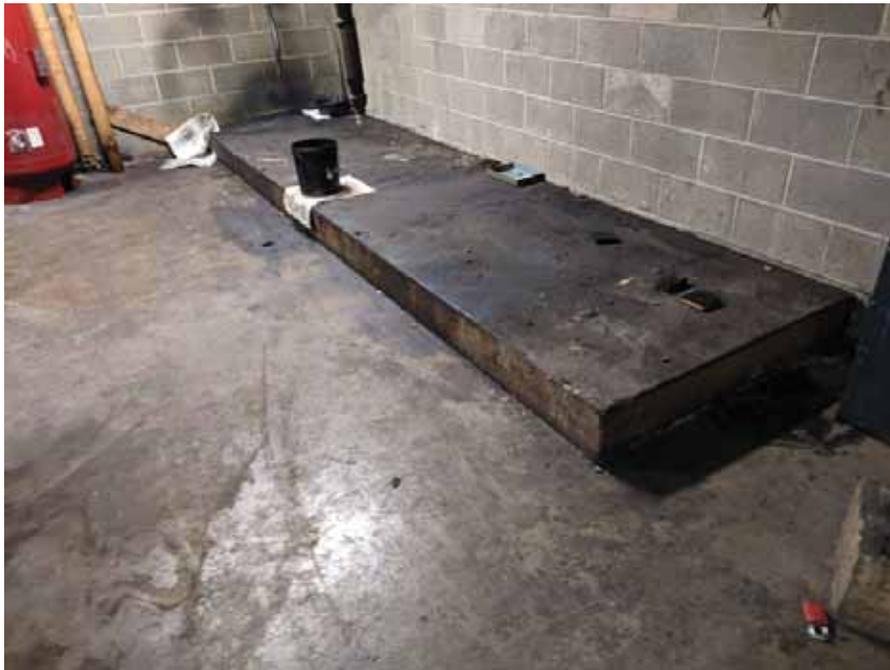
Photo 66: View of oil staining on the concrete in the second floor mechanical room of the Sears Auto Center.

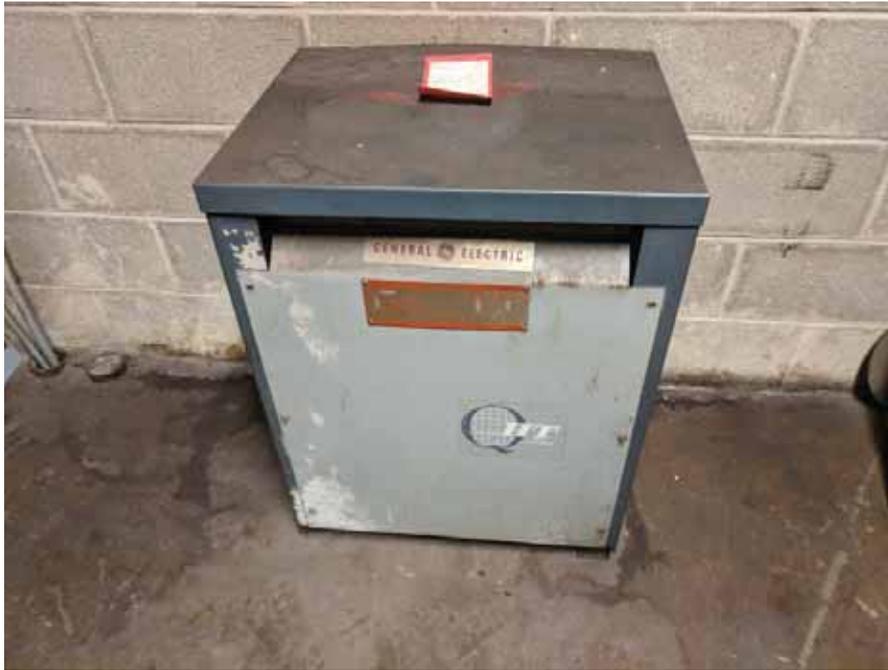
Photo 67: View of a dry-type transformer located in the mechanical room on the second floor of the Sears Auto Center.
